CASE STUDY : PLASMET ZF FOR PIPE-BRIDGE

STRUCTURALLY DANGEROUS PIPE-BRIDGE RESTORED TO 'AS NEW' CONDITION

Water & Waste industry, UK

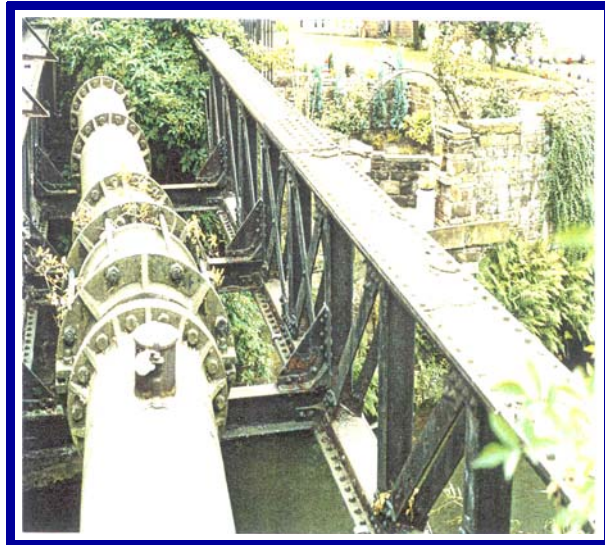
Top: Pipe-bridge before refurbishment.

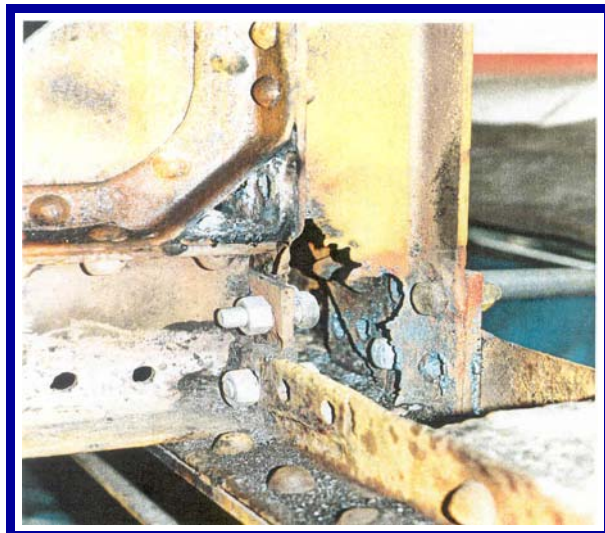
Middle: Lower chord to vertical joints after grit blasting.

- Grit blast to ISO 8501-1 cleanliness standard Sa2½ .
- All joints encapsulated using Corrocoat's Polyglass material.
- Total structure and externals of the pipe were treated to two coats of Plasmest ZF and a top coat of Plasmest ZX.

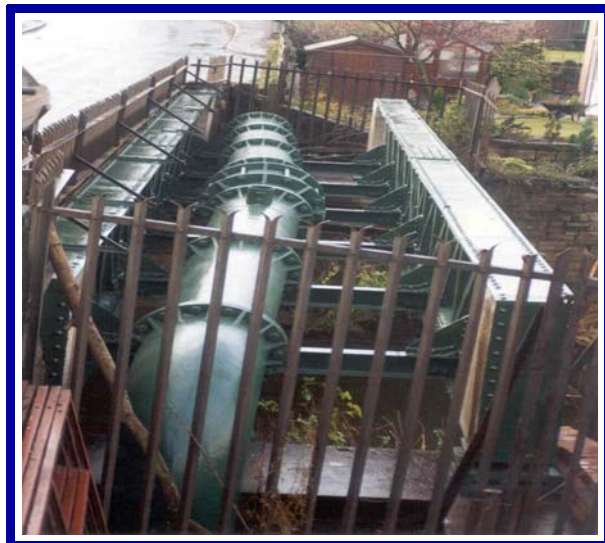
Bottom: Job completed, bridge fully refurbished
