***OIL COOLER HEAT EXCHANGERS***  
*Case Studies*

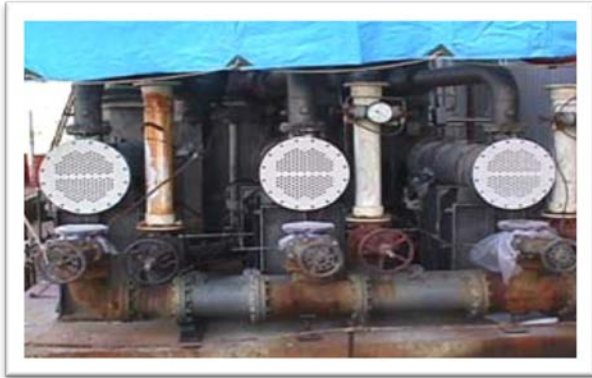
### Oil Cooler Heat Exchanger

These heat exchangers were originally epoxy coated. On inspection the tube sheets were badly corroded and the client considered replacement of the tube sheets and tubes with 8 weeks down time. Corrocoat repaired and coated the existing sheets with the Corroglass 600 series in just 4 days and at 10% the cost of replacement.

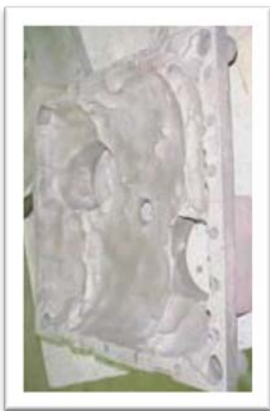
**Left:** This water box was blasted, decontaminated and exhibited severe corrosion, holes through the casing and the division plates were virtually corroded away.

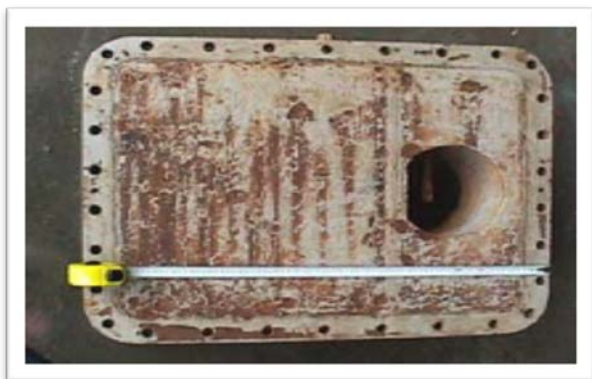
### Water Cooled Condenser End Covers

The end cover shown here was painted 5 times in 10 years with Epoxy paint. Under the paint it had corroded and there was deep pitting. The end cover was blasted, repaired and coated with the Polyglass 600 series. There was no corrosion or maintenance required for the next 10 years.

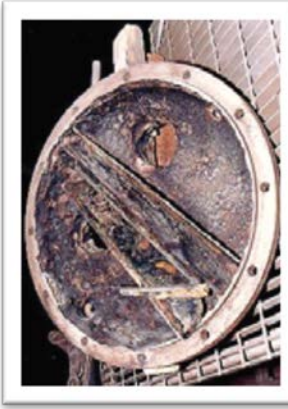
**Left:** This cast iron end cover had been in service for 2 years and was severely corroded.

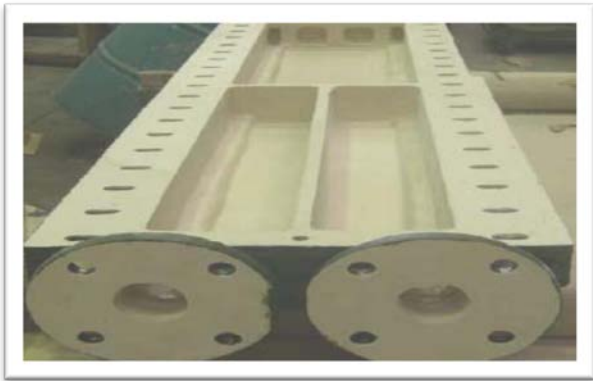
### Motor Oil Cooling Water Box

This water box was severely corroded by seawater and was leaking badly. Corrocoat repaired the leaks and pitting and rebuilt the division plates using the Corroglass 00 series and glass matting. The external surfaces were protected using Plazmet ZF.

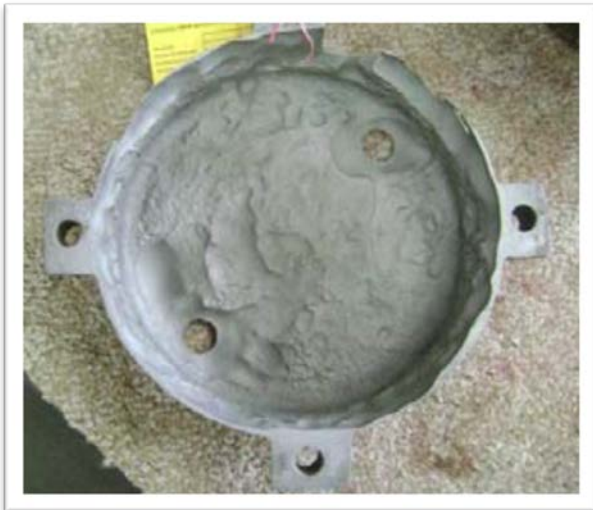
### Condenser End Covers

This condenser end cover was considered scrap; however Corrocoat was able to rebuild it using a composite laminate of the Corroglass 600 series and Kevlar matting. Two stainless steel sockets were welded in place and the end covers put back into service without the risk of future corrosion and at a fraction of the replacement costs.
