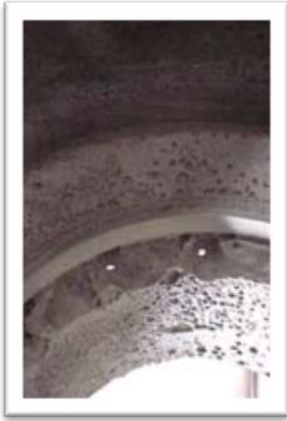
Condenser Water Pump

Severely Corroded Ajax Pump

Left: The pump inlet as we received it. Note the deep pits and holes in the casing.

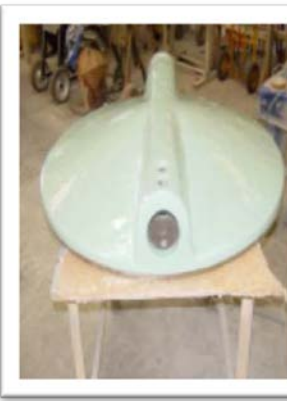
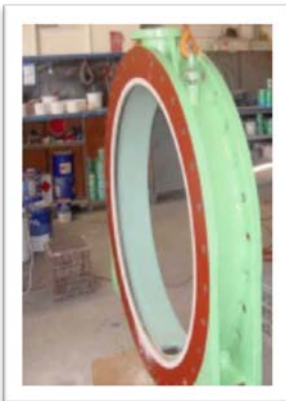
48" Butterfly Valve Refurbishment

The valve flap and body had deep pits and metal loss around the sealing edges. As a result the valve had become totally ineffective. The valve was totally refurbished old for new with a 20 year life expectancy. The refurbishment of an existing valve can provide considerable savings over expensive metal castings or new valves with changes to pipework.

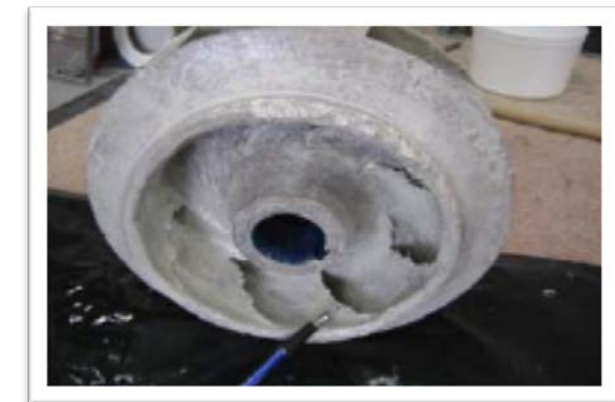
Sea Water Pump

This impeller has been blasted, treated for salt contamination and primed with one coat of Corroglass 600. Note the severely corroded impeller vanes. They were rebuilt using a composite of Kevlar matting and 600 series. After coating the impeller is balanced and Fluiglides is applied to reduce friction and increase efficiency.

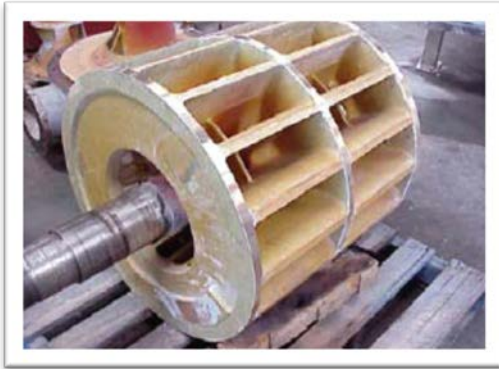
Nash Acid Vacuum Pump

Prior to this photo the pump was considered scrap due to its badly corroded condition and loss of efficiency. The pump was fully refurbished by Corrocoat and after ten years shows no signs of corrosion. As well as the obvious savings in replacement costs; the original cause of the failure, corrosion, is eliminated and there is no need to change piping or footings.

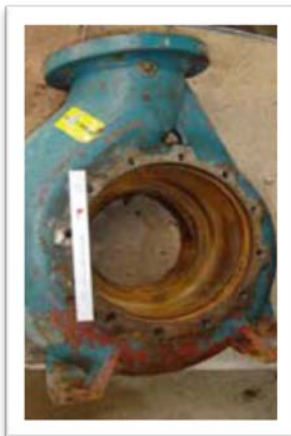
Cast Iron Water Pump – Southern Cross

The photo on the **left** shows the pump severely corroded and eroded with considerable metal loss due to acidic water. Prior to Corrocoat's involvement the pump was being replaced every 6 months. The photo **right** shows the fully refurbished pump which will operate with no corrosion at reduced power consumption and no loss of production.

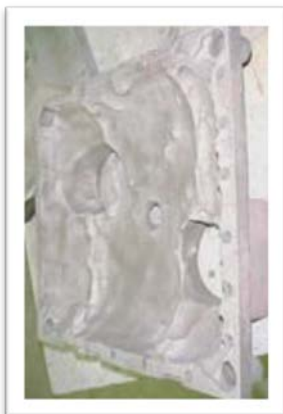
Ship Lady Elaine

Left: This water box was blasted, decontaminated and exhibited severe corrosion, holes through the casing and the division plates were virtually corroded away.

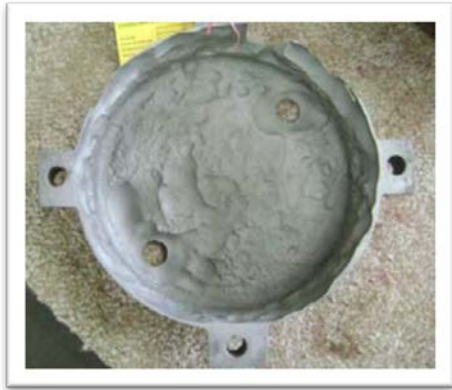
Sea Water Condenser End Covers

Significant Metal Loss

This condenser end cover was considered scrap; however Corrocoat was able to rebuild it using a composite laminate of the Corroglass 600 series and Kevlar matting. Two stainless steel sockets were welded in place and the end covers put back into service without the risk of future corrosion and at a fraction of the replacement costs.

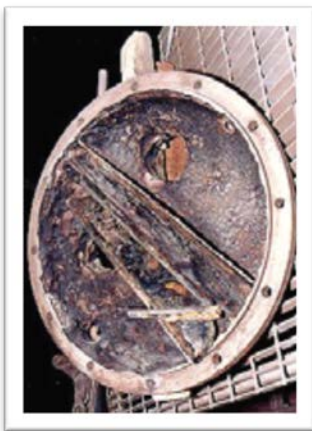
Sever Metal Loss Due to Water and Galvanic Corrosion

Left: This cast iron end cover had been in service for 2 years and was severely corroded.

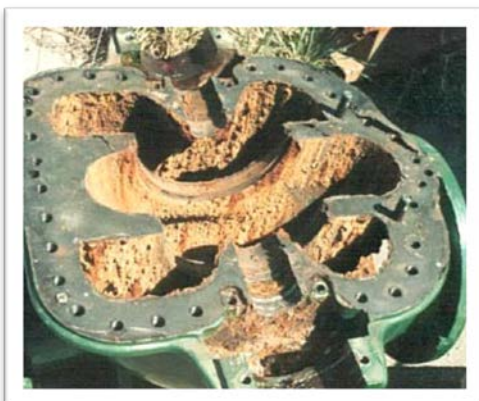
Worthington Pump

Severe corrosion, deep pitting and corrosion deposits resulted in poor performance, increased pumping costs and its untimely failure. All internals were rebuilt and re-profiled using the 600 series. The wear rings and landings were built up with Corroglass and machined to original size. A top coat of Fluiglides was applied to reduce friction. The savings in power consumption paid back the repairs in 15 months.
