CASE STUDY : CORROGLASS 600 FOR RISER PIPES

SEAWATER PUMP RISER PIPES MAINTAINED AFTER 21 YEARS.

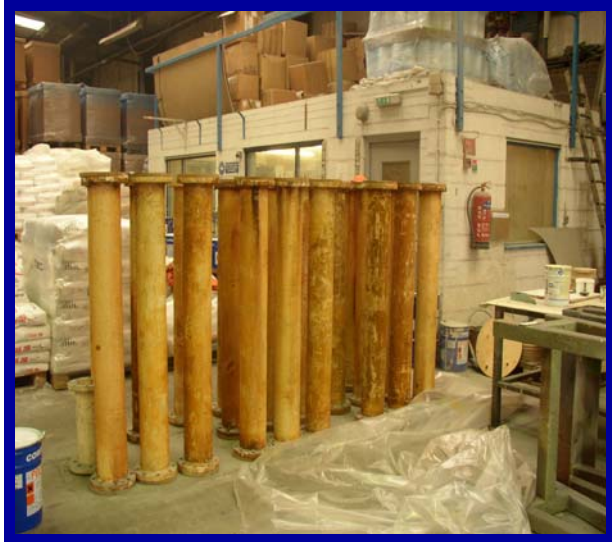
During the service life, which comprised of external exposure to seawater (immersed, splash zone and atmospheric), and internally, seawater with a low hydrochlorite dosing (≈4%), the coating has not shown any tendency to undercut, and only minor mechanical damage was needed to be repaired.

Top: The pipes as returned after 21 years service.
Middle: Flange area illustrating no under-cutting.
Bottom: Pipes in coating – almost complete.
