CASE STUDY: CORROCOAT PROTECTS SPILLWAY GATES

CORROSION PROTECTION FOR AUSTRALIAN SPILLWAY GATES

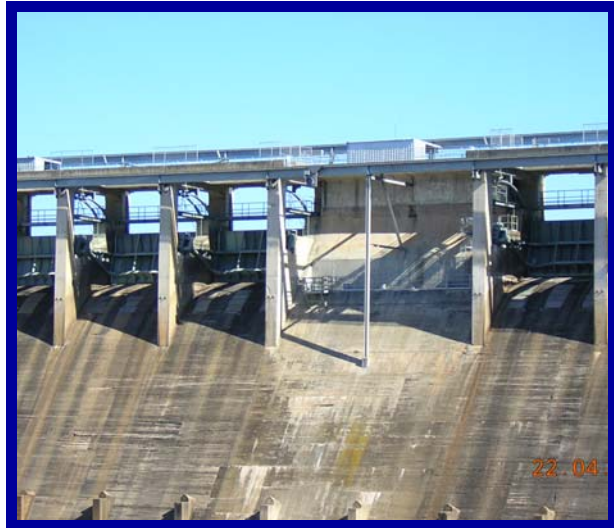
The spillway gates at Glenmaggie. Access to the gates was the first hurdle for Corrocoat.

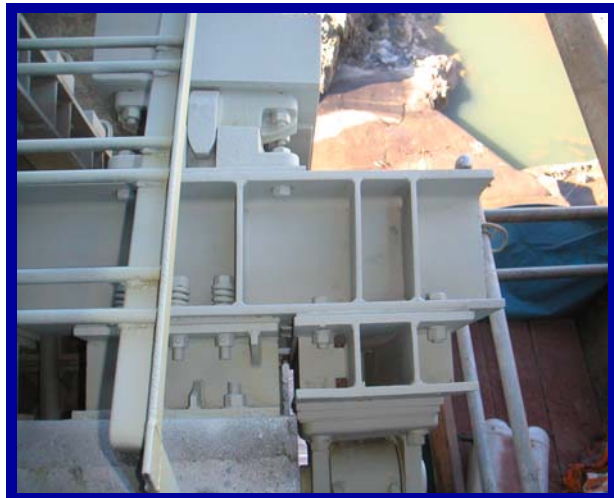
One of the spillway gates after coating – note the complex geometries.

- Grit blast to ISO 8501-1 cleanliness std Sa3
- Polyglass VEF applied at 1000µm dft.
- Polyglass 100 Zipcoat applied at 1000µm dft.
- Plasmet HTE applied at 2000µm dft.
- Plasmet ZF applied at 400µm dft.

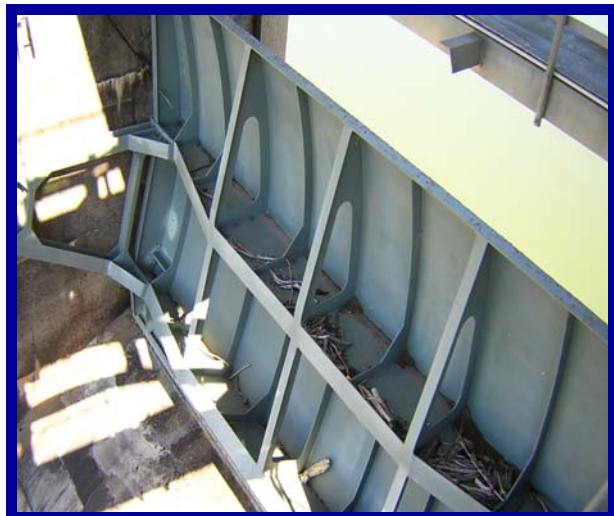
- Inspections in 2004 have revealed that whilst further deterioration of the epoxy resin / coal tar epoxy coated gates is evident, no such deterioration of the three gates coated using Corrocoat's system was noted by the delighted customer, with the equipment remaining in excellent condition.

Visual inspection of one of the gates after service – showing no coating breakdown.
