## Corrocoat USA Case Study: South Georgia Pellet Mill Exhaust Elbow Wear Resistant Lining

Pellet Mill – South Georgia

The Internal Lining of the Impact Zone of an Exhaust Elbow

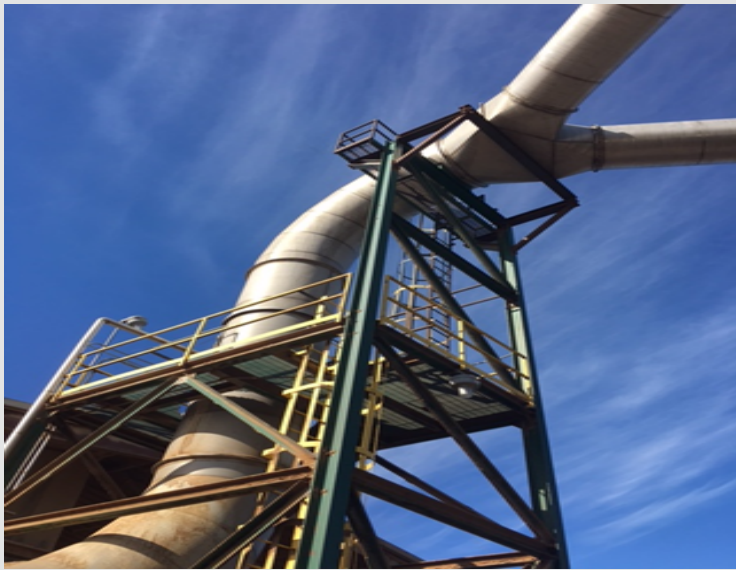
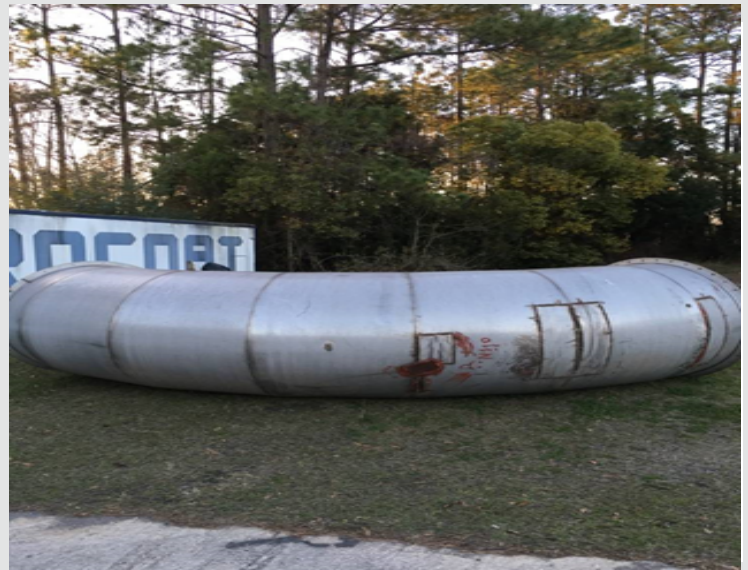
The service environment includes excess wood pellets / chips which have been de-moisturized via an evaporator drum, which is upstream from said elbow. The elbow is located approximately 200' from the drum. The average operating temperature at the drum is 214°F, with a maximum operating temperature of 248°F. The pictures at the top of the page show a received condition of the pellet mill, while the one on the bottom displays a finished pellet mill after a skim coating of Plasmet HTE was applied to it.
