CASE STUDY: CORROCOAT 'E' SERIES FOR A VENTURI

Refurbish and protect a venturi from a sea-water, condensate water system.

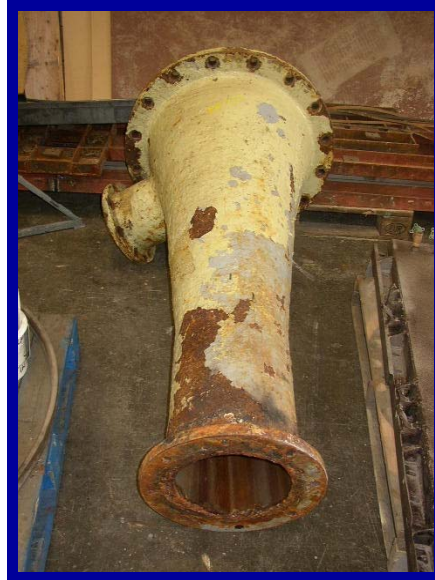
The component illustrated cavitation and undercutting damage, with severe corrosion around the flange area.

The venturi on arrival in our Leeds works.

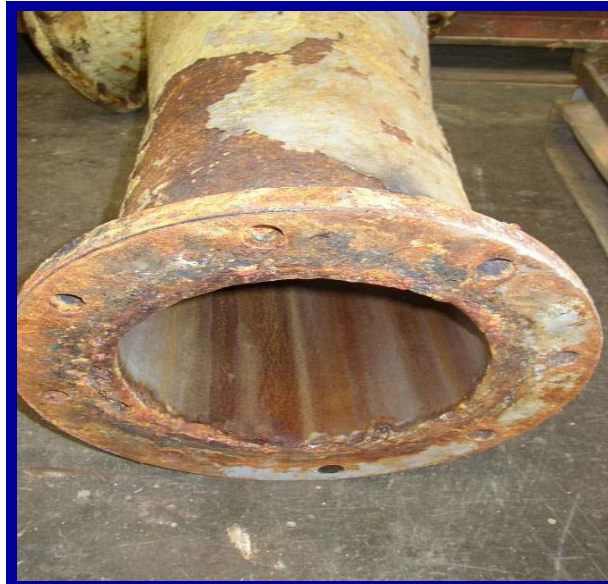
Severe undercutting & cavitation damage in the flange area.

- Grit blasted internally to ISO 8501-1 cleanliness standard Sa2½.
- Grit blasted externally to ISO 8501-1 cleanliness standard Sa2.
- Applied internally Corrocoat EA / EB to achieve a minimum dft of 2.0mm followed by a top coat of Fluiglide E.
- Applied externally 2 coats of Plasmet ZF followed by a cosmetic top coat.

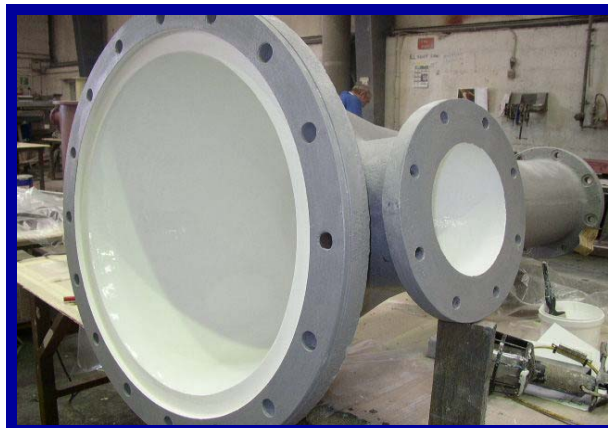
Completed repair and refurbishment. Awaiting packing and despatch to customer..
