CASE STUDY : CORROGLASS 600 FOR FAN UNIT

CORROSION PROTECTION FOR FAN UNIT

Protection of new impeller and casing, designed for use in aggressive conditions.

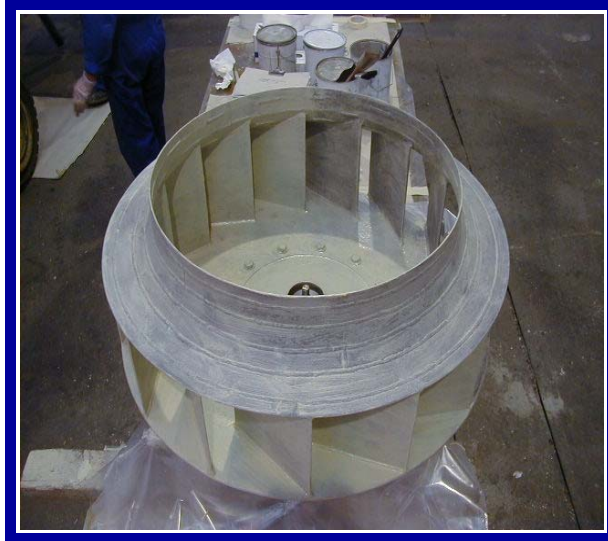
Top: Impeller in coating shop after grit blasting and primer coat.

- Internal:- The impeller was grit blasted to ISO 8501-1, Sa 2½ and treated using Corroglass 600 Series materials.
- The casing was grit blasted internally to the same standard, followed by application of Corroglass 600 Series to a minimum dry film thickness of 1mm, carried into the flange rebates and finished flat to ensure optimum performance in use
- External :- The area was grit blasted to Sa2 and protected using two coats of Plasmet ZF.

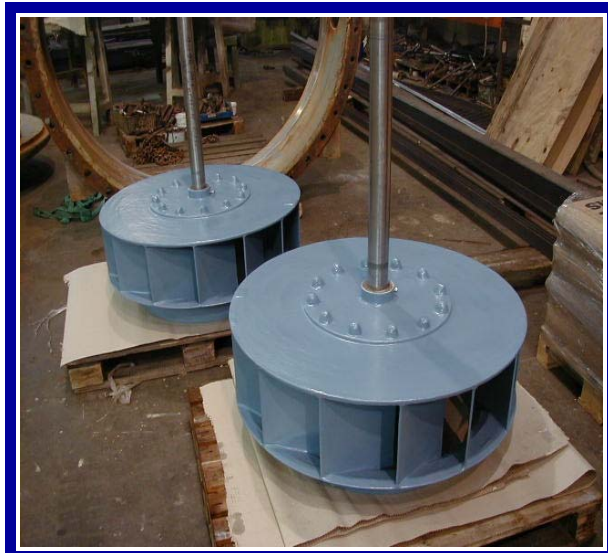
Middle: The fully completed and inspected impellers.

Using Corrocoat's Engineering facilities the impeller was fully balanced to BS6861-pt1

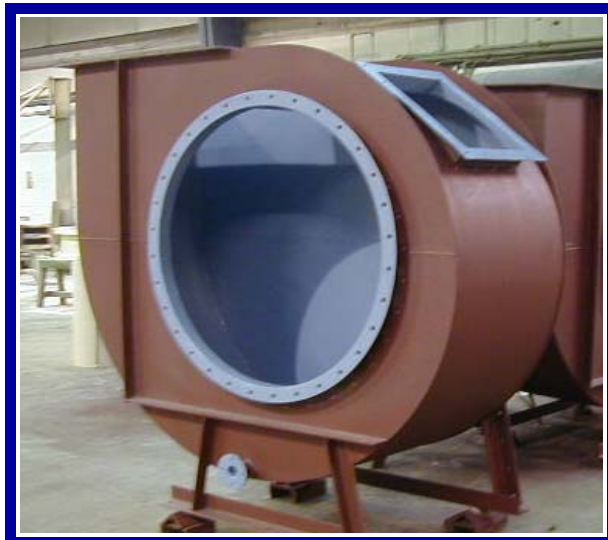
Bottom: Casing completed, awaiting despatch.
