# CASE FILE : OIL COOLER WATERBOX COVER

## TOTAL REPAIR AND REFURBISHMENT OF MAIN OIL COOLER WATERBOX COVER

Major UK Refinery

December 2006

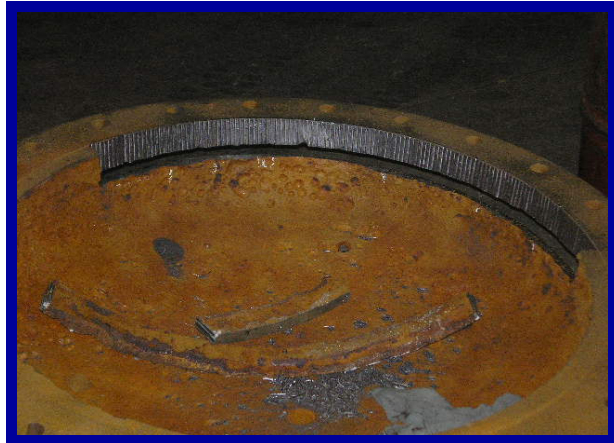
*Top:* Damage cut out

The Cooler Water Box covers would be considered beyond repair for most companies, without the established refurbishment expertise of Corrocoat. Cracking of the cover was stabilised by performing external metal stitch repairs. The internals were then re-profiled, followed by blasting and coating using a high build vinyl ester coating.

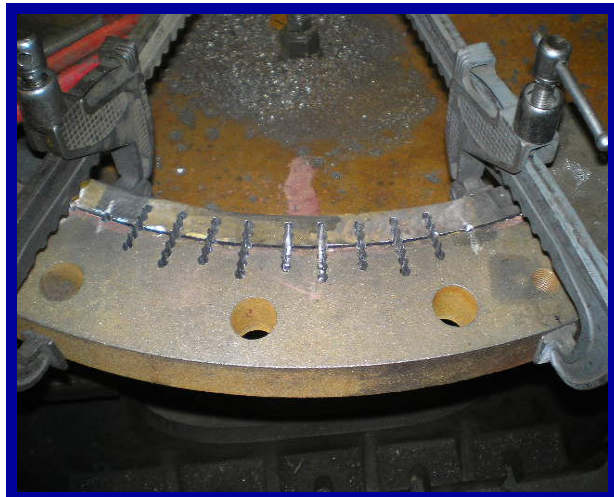
*Middle:* Stitching detail

Remove existing coating. Pre machine rebates. Grit blast internals to ISO 8501-1, SA2.5. Carry out metal stitch repair.

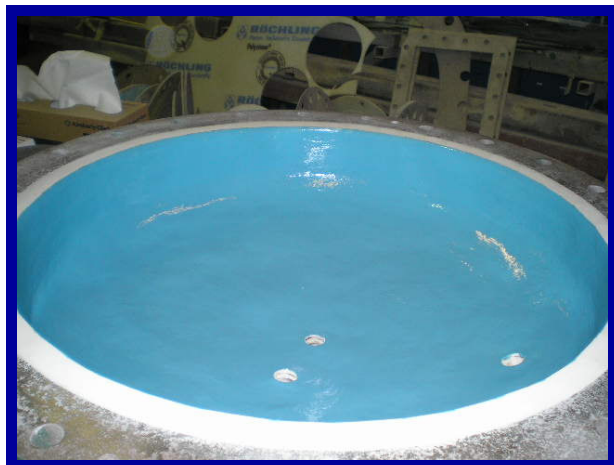
*Bottom:* Internals, coated

Coat using Corroglass 600 to a minimum dft of 1.5mm. Post machine. Grit blast externals to ISO 8501-1, SA2.5.
