Corrocoat USA Case Study: Central Florida Power Plant

98% Sulfuric Acid Secondary Containment Repair and Lining

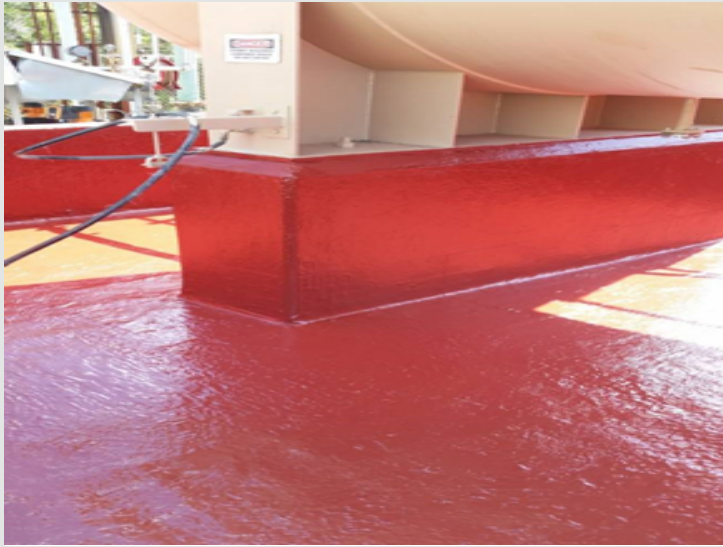
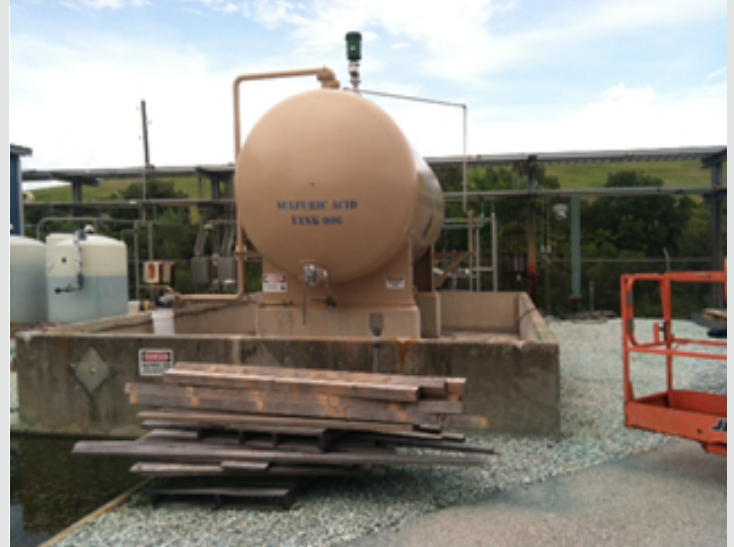
Existing paint was blasted off and the surface was blasted to remove contaminants and all loose concrete. Plasmet ECP (Epoxy Concrete Primer) was applied via roller / brush to 4-6 mils wft (Wet Film Thickness); verified by a wet film gauge.

The solution includes applying Corrofill E at Floor-Wall Transition, and to fill Pits.
