CASE STUDY : COARSE WATER FILTER SCREENS PRO-

**BIOFOUL ANTI-FOULANT:
ECO-FRIENDLY, MECHANICALLY
STRONG & GIVES EXTENDED LIFE**

Power Industry, UK

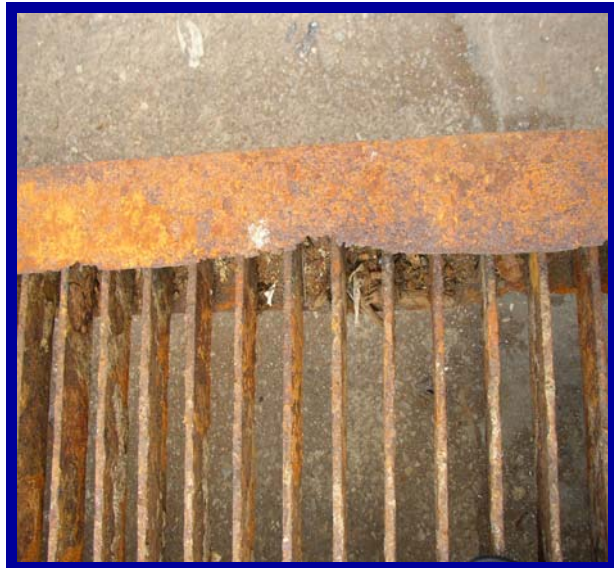
Top: The screen after pressure washing – showing the extent of corrosion and pitting.

Prepare screens by pressure washing, manual cleaning & scraping, then abrasive blasting to remove marine growth, debris and corrosion deposits. Assess repair work. Apply corrosion protection and Biofoul.

- Grit blast whole structure to ISO 8501-1, cleanliness standard Sa 2½ with minimum surface profile of 50µm.
- Apply Polyglass PPA to whole structure as a primer for the Corrocoat 600 Series, applied to a min.dft of 1.5mm.
- Apply top coat of Biofoul.

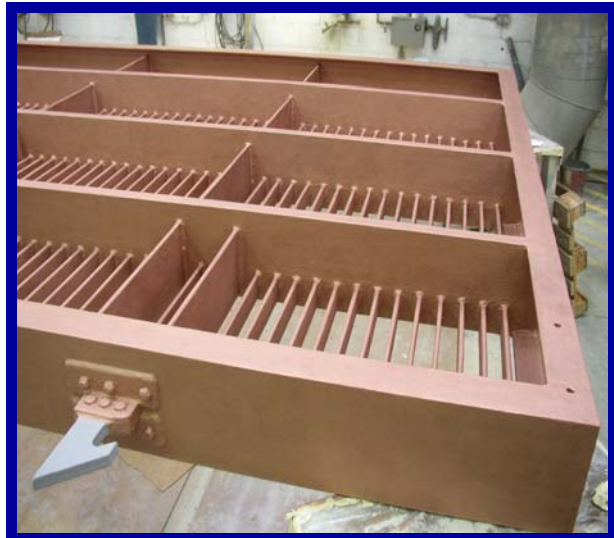
Middle: Detail of the re-profiled cross-members.

Corrocoat 600 Series for repair and re-profiling, with a Polyglass PPA primer coat. Top coat of Biofoul applied for anti-fouling requirements.

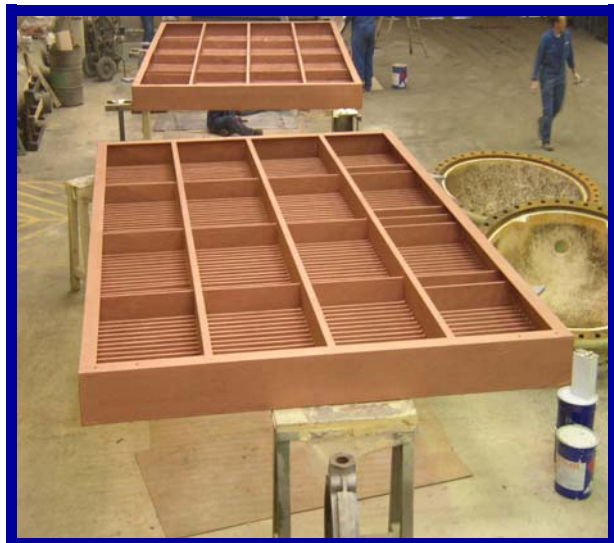
Bottom: The completed screens awaiting despatch.
