Ravensthorpe Nickel Project

Multiple Tanks & Thickeners up to 138' Diameter

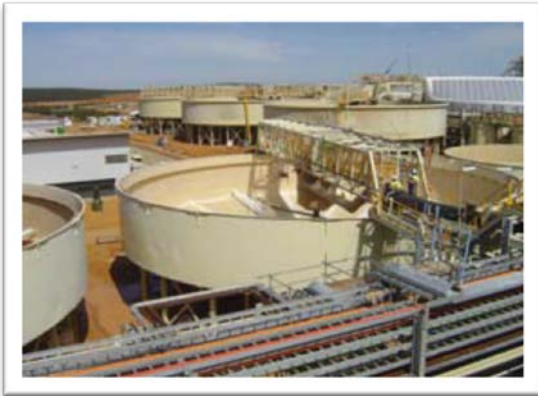
The Ravensthorpe Nickel project involved the lining of 53 tanks over a 20 month period. A total area of 9 acres was coated requiring 19,812 gallons of Corrocoat material. Corrocoat products were selected after years of testing by BHP and Corrocoat's R&D chemists in the UK.

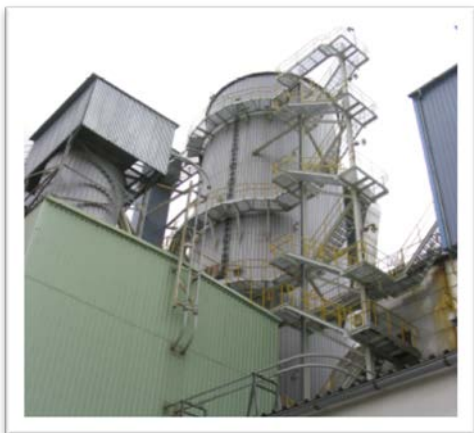
High Temperature Protection in a Desulphurization Plant

Following the failure of an Epoxy coating after 3 years Corrocoat were asked to refurbish the internal coating of the absorber. XT was used on the upper areas where working temperatures were close to 200°C and VEF was used on the remainder of the absorber.

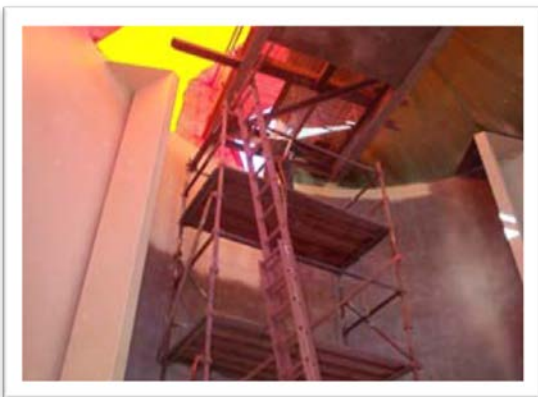
In 1998 extensive testing was conducted to find a replacement lining for failing 6mm rubber lining in the Roxby Downs leach tanks. Polyglass VEF at 1mm thick was selected and applied by Corrocoat and the coating has operated without fault since that time.

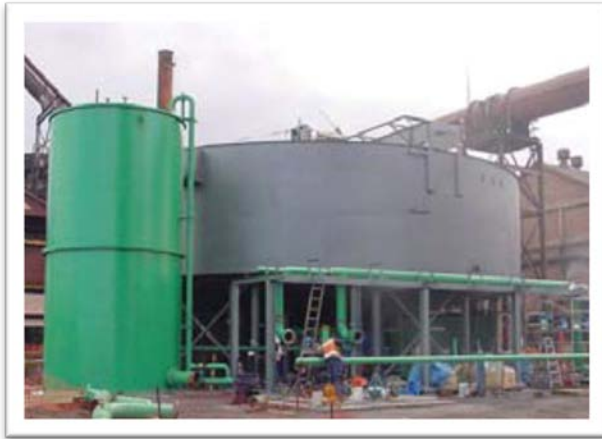
Blast Furnace Water Treatment Plant

The process environment is seawater with traces of ammonia and sulphuric acid with a pH of 7 to 8.5 at 50°C - 82°C. The high chloride content at elevated temperatures results in rapid corrosion of steel tank and components. Polyglass VEF was used to eliminate all corrosion issues.

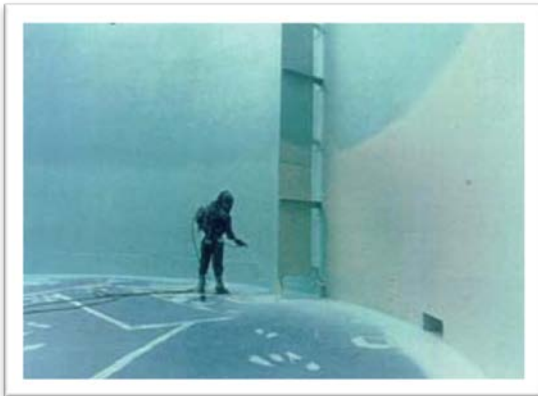
Tank Corrosion and Sulphate Reducing Bacteria (SRB)

This is one of 7 CIL steel tanks that were suffering from SRB's and associated corrosion under the original coating. The old coating was removed and the tanks and baffles coated with 1200 microns of Polyglass VEF which is totally unaffected by SRB's. All corrosion issues were eliminated.

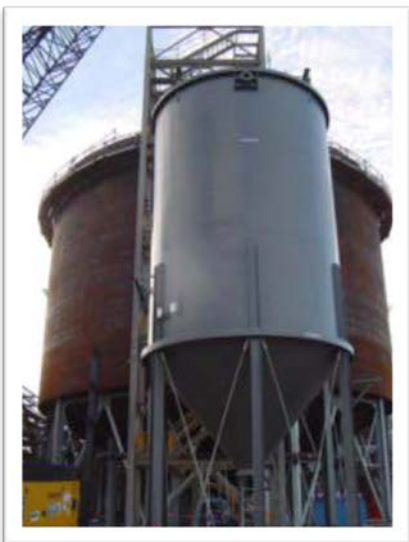
Internal Lining of Three (3) Acid Tanks

Three tanks containing varying concentrations of seawater, H₂SO₄, Na₂CO₃, Lithosolvent and NaOH at 80°C were coated with 1000 microns of Polyglass VEF to provide corrosion protection to the carbon steel tanks, roof, baffles and agitators.

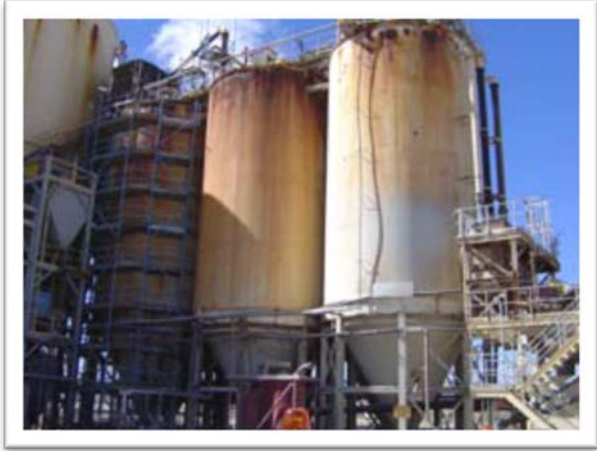
Adsorption Tank Refurbishment

The existing tanks were severely corroded due to the activated carbon slurry. The tank was blasted, repaired and all pitting filled with Corroglass 600 series. The internals were then sprayed with 1000 microns of Polyglass VEF.

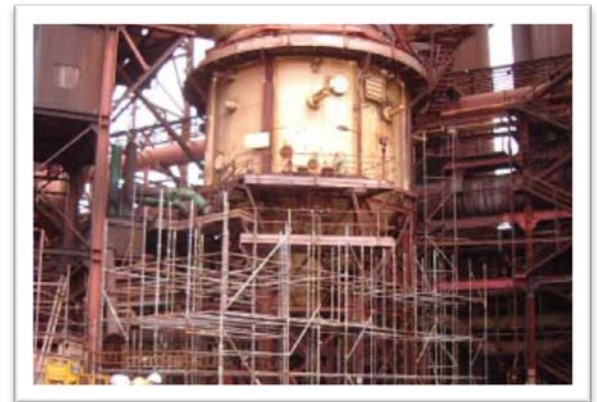
Venturi Scrubber— Victoria

Prior to Corrocoat's involvement this critical pressure vessel required repairs every 6 months due to corrosion and leaks. The vessel was repaired and internally lined with Polyglass VEF to a thickness of 1.5mm and has remained corrosion free for over 9 years.

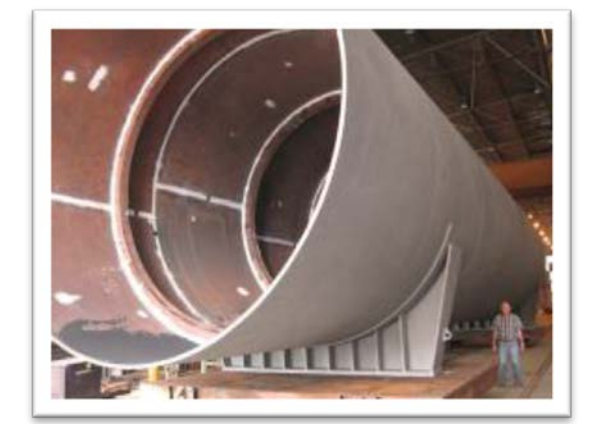
Underground LP Gas Bullet

These bullets are buried in chloride rich coastal soil in a high rainfall area and the refinery found other coatings blistered within 5 years due to Cathodic disbondment. Polyglass VEF was selected and two coats to a thickness of 1500 microns was sprayed to the external of each bullet.
